eAir REPAIR

November 2010

Bad Oxygen Sensor Right Out of the Box

By: Scott Shotton from *The Driveability Guys*

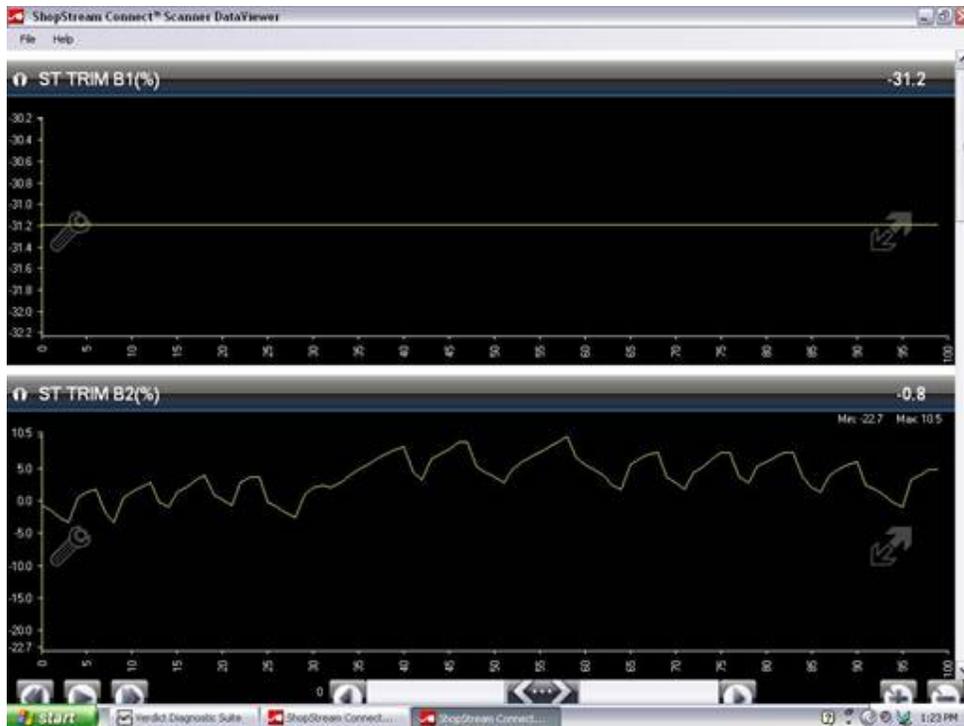
First, I connected my scan tool and pulled a P1166 – Lambda Bank 1 Control Limit. Being fuel related, I chose to look at fuel trims next. The image below is of the short term trims with bank 1 locked at 31.2% and bank 2 averaging around 2% to 4%. So bank 1 definitely had an issue.

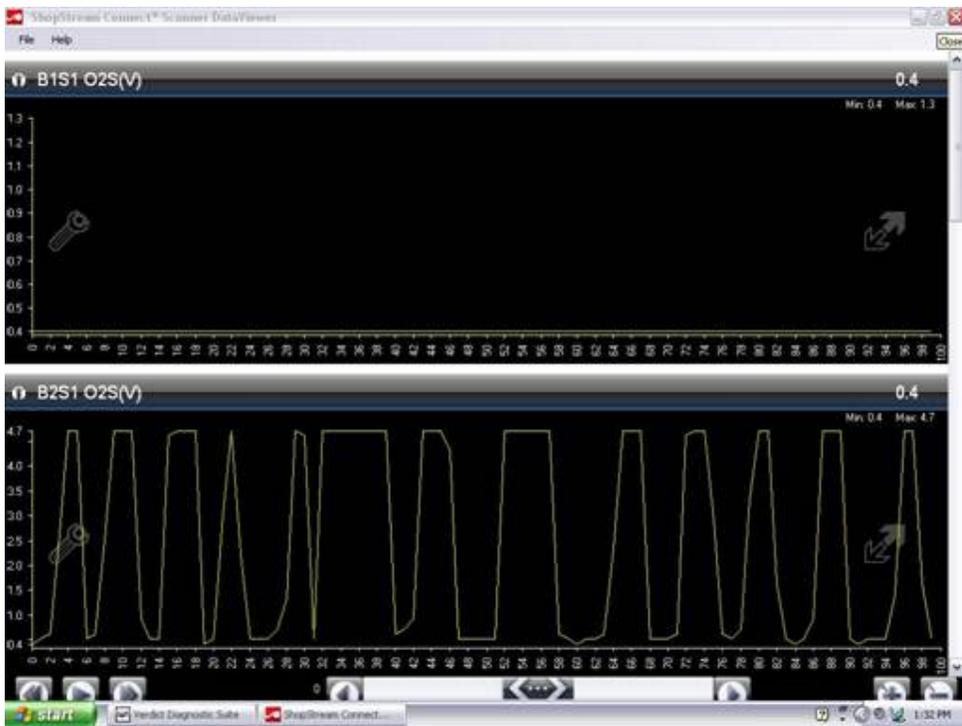
Second, I wanted to see the oxygen sensor signals. Below are the graphs for both upstream oxygen sensors while the vehicle was idling. Bringing up the RPM's caused very little change to their appearances. Bank 1 was flat at 0.4 volts while bank 2 was switching between 0.4 volts and 4.7 volts. The bank 1 sensor turned out to be the replacement sensor. Could it be completely dead right out of the box?

There was something else that seemed a bit odd to me. If bank 1 is showing lean on the oxygen sensor signal, why is the short term trim showing that the PCM is taking away fuel instead of adding it? Also, even though bank 2's switching appears good, why the high voltage range? Just as a double check I confirmed that the vehicle was running lean with my exhaust gas analyzer. I guess it is time to do some research.

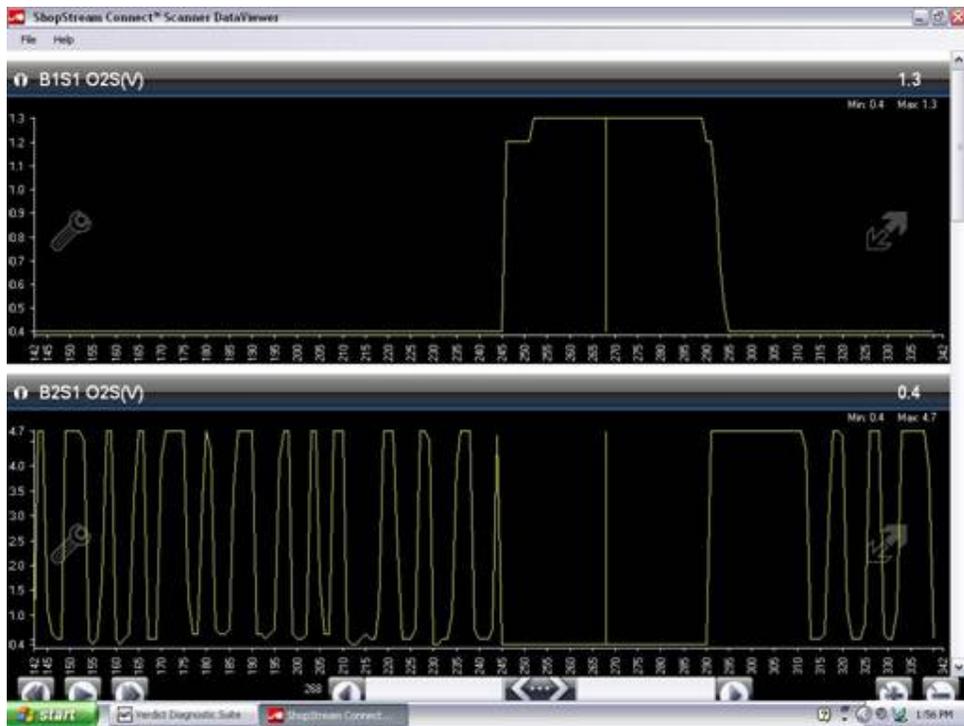
Note the difference in the voltage range of the two different sensors and how the rich/lean ends of the voltage spectrum are opposite each other. Could the oxygen sensor that was installed in bank 1 be the wrong type of sensor for this vehicle? Possibly, but let's prove it. I figured if I add propane to the intake I should be able to see the operation of both sensors and verify that very thought.

Halfway through the above capture I injected the propane. Notice how the bank 1 sensor rose to just over 1 volt. That looked like a conventional zirconium type oxygen sensor to me. And bank 2 just as the TSB described for the titanium type: 0.4 volts indicating a rich condition. This vehicle did have a functioning oxygen sensor installed in bank 1, it just happened to be the wrong type. I don't know if the original sensor was actually in need of replacement, but I was pretty sure it needed to be replaced again.
